HADLEY CROW STUDIO
Architecture and Landscape Architecture
P. O. BOX 1917 ORLEANS MA 02853
508.255.8001 info@HADLEYCROWSTUDIO.COM

EAST
ELEVATION

DWG. NO. A-4033

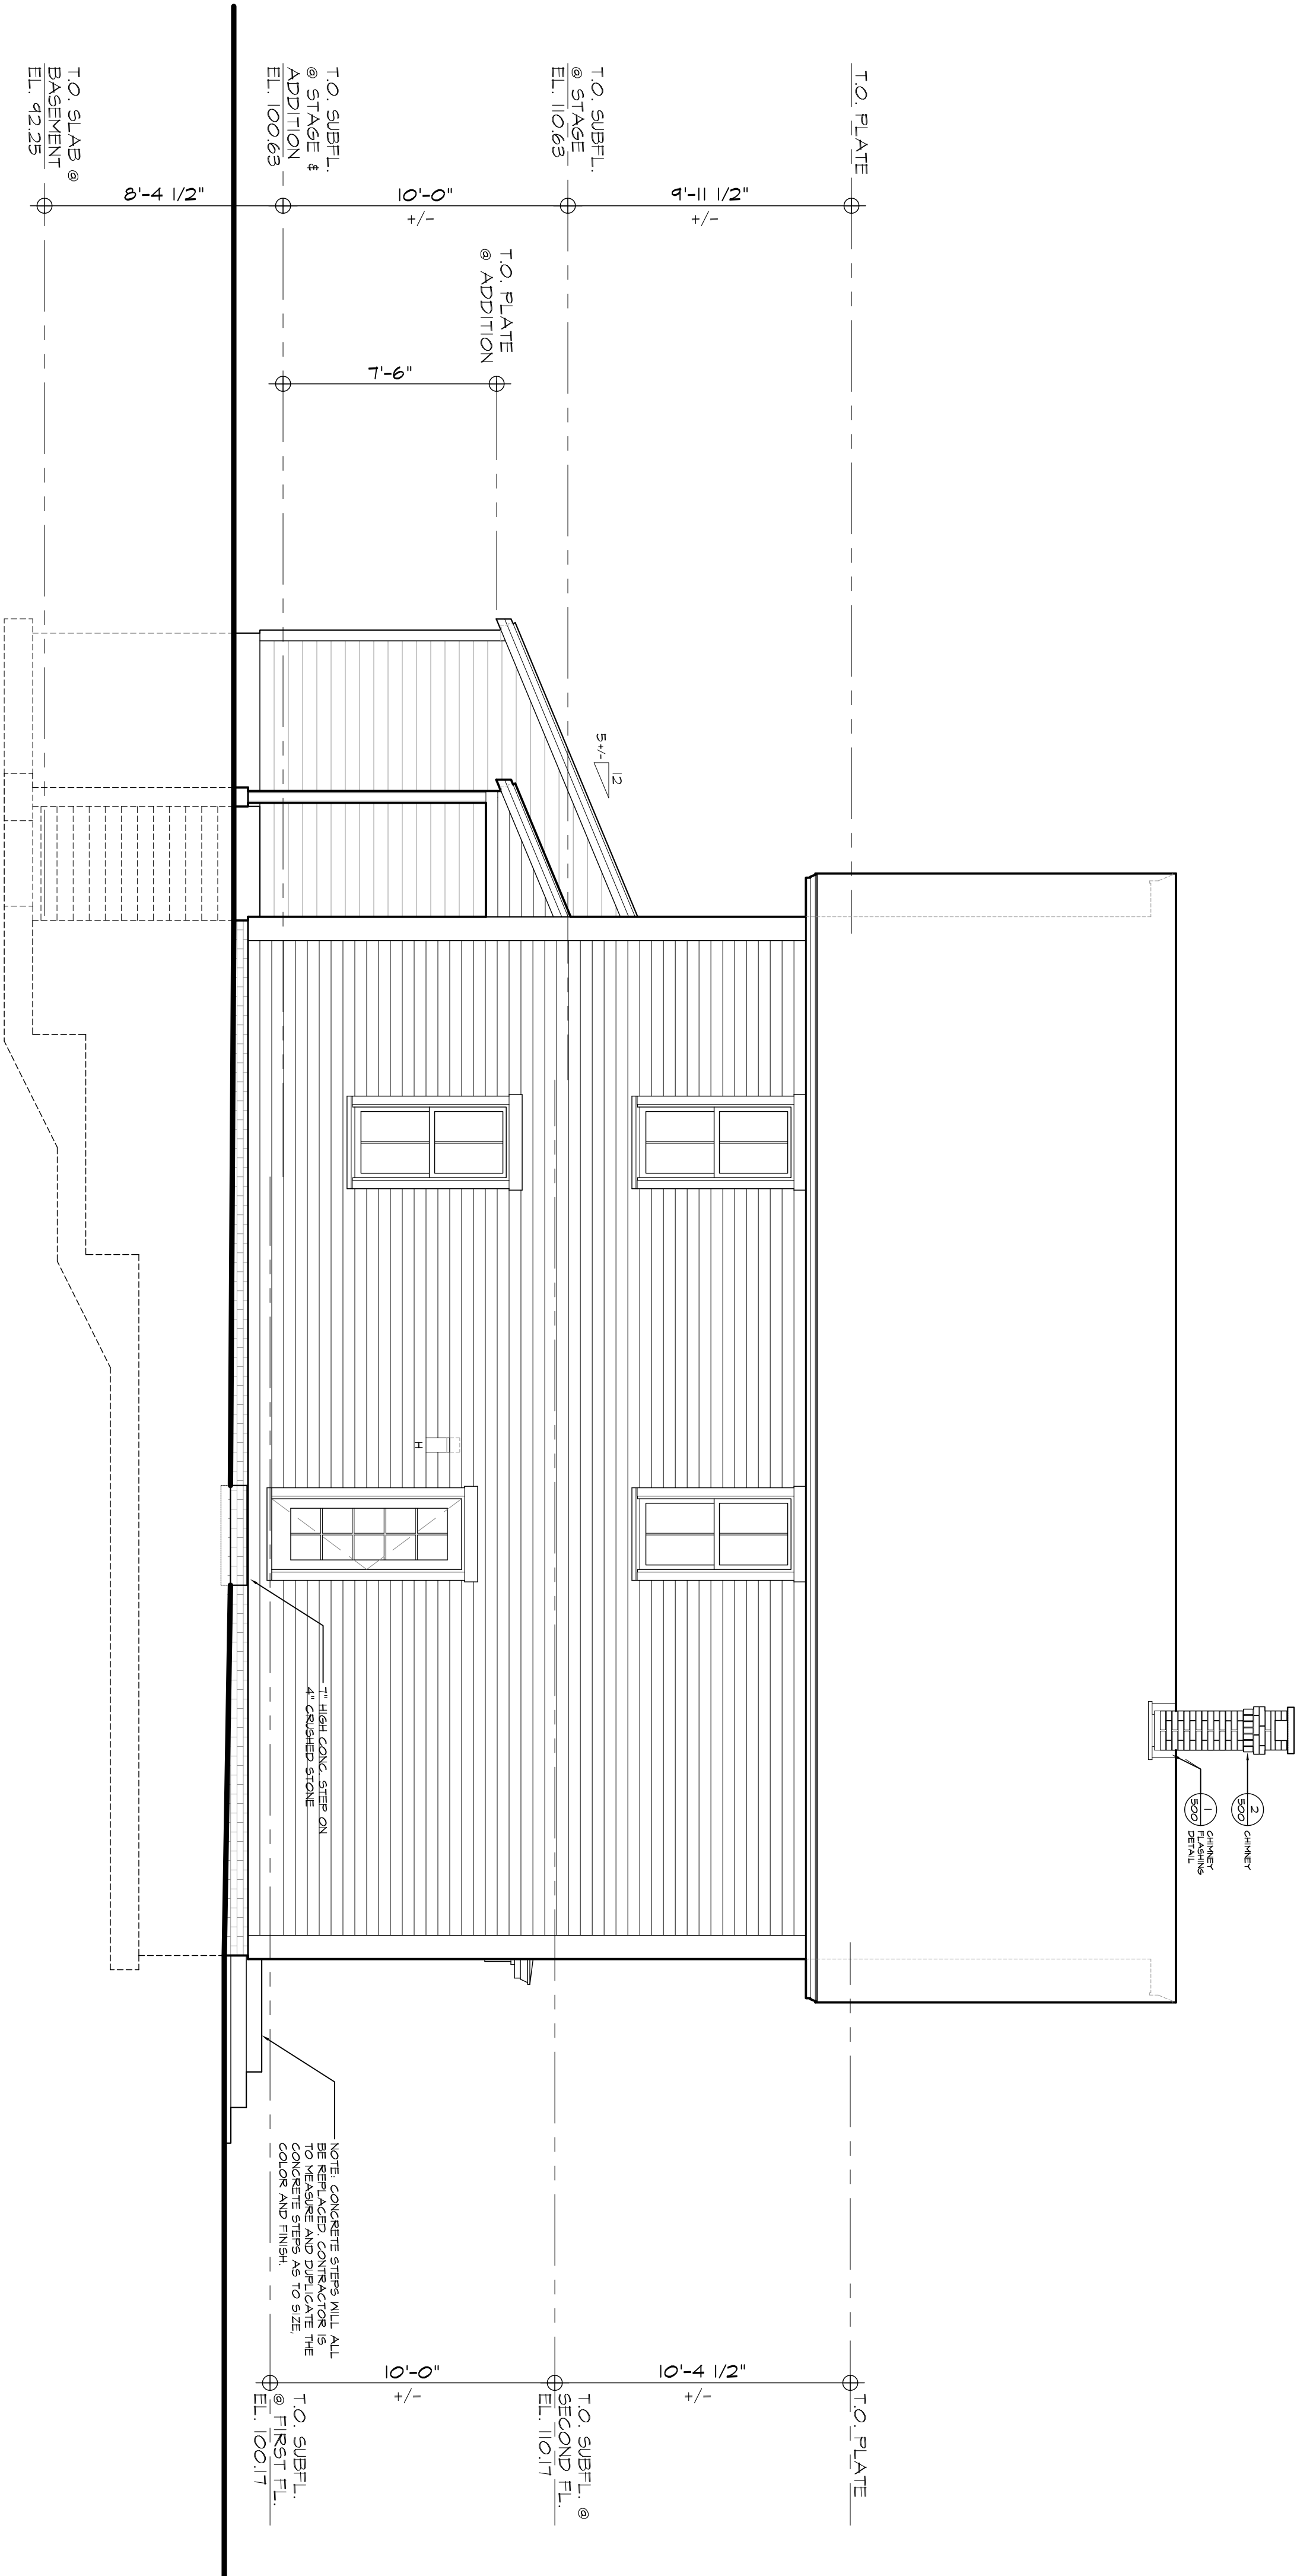
PROPOSED EAST ELEVATION

Exterior Restoration Notes

East Elevation

Removals: Remove any deteriorated wood siding or trim, taking care to remove only the amount needed to effect a watertight and paintable repair. Remove substrate at badly deteriorated areas exposed at NE and SE ends and at existing door.

Restoration: Repair/restore wood framing, sheathing, siding and trim as listed in project specifications. Repair/replace door frame and threshold. Install new lead flashing below new door threshold. Paint all wood to match historic colors provided by project conservator.
